**Concern-**

Our homeowner moved into this home and the \$4,000.00 grill was already there. Unfortunately, the grill was neglected and not working. Should the homeowner scrap the grill and purchase a new one or should he pay to have it refurbished?

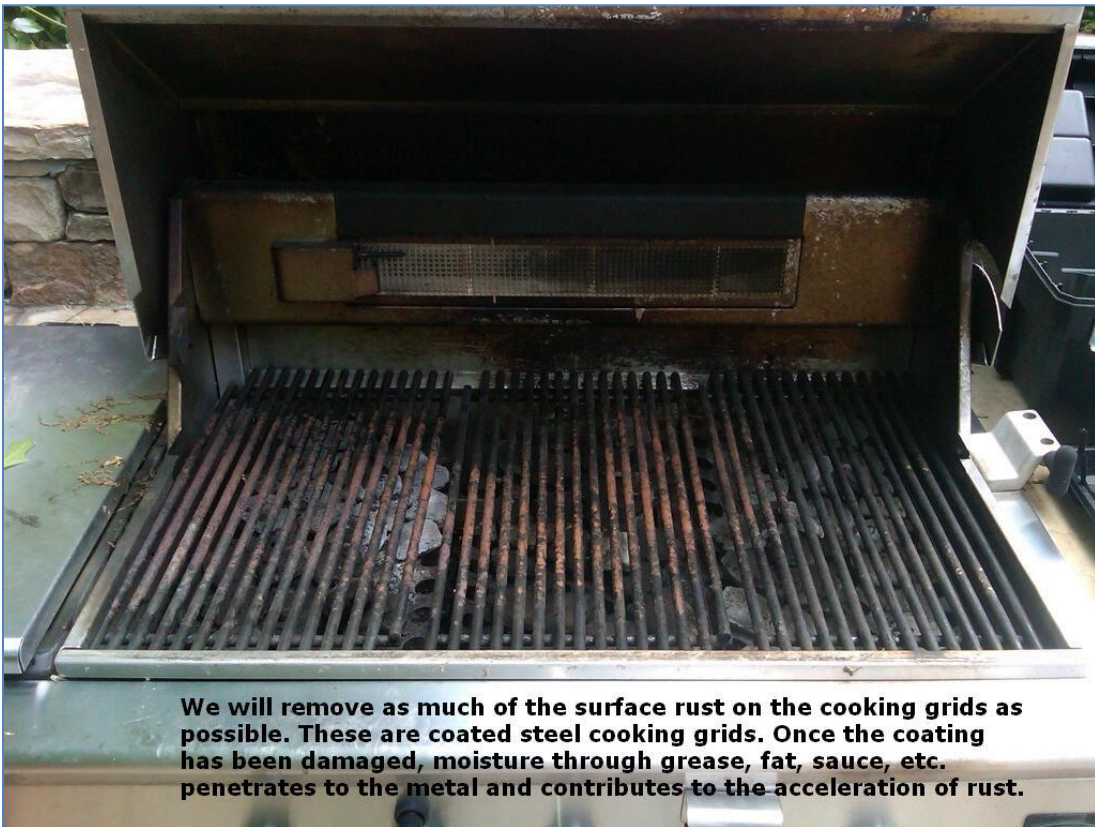
**We will remove as much of the surface rust on the cooking grids as possible. These are coated steel cooking grids. Once the coating has been damaged, moisture through grease, fat, sauce, etc. penetrates to the metal and contributes to the acceleration of rust.**

- 1- Grill Cleaning (built-in grill)- \$295.00
  - 2- (3) Burners @ \$124.12 Total- \$372.36
  - 3- (3) Cooking Grids @ \$98.27 Total- \$294.81
  - 4- (3) Burner Covers @ \$42.91 Total- \$128.73
  - 5- (2) Gas valves @ \$49.17 Total- \$98.34
  - 6- (5) Rotary Piezo spark generators @ \$19.66 Total- \$98.30
  - 7- (5) Sparking electrodes @ \$18.56 Total- \$92.80
  - 8- (1) Smoker box burner @ \$34.51 Total- \$34.51
  - 9- (1) Shipping for all parts @ \$20.00 Total- \$20.00
  - 10- (1) Labor to install all parts @ \$50.00 Total- \$50.00
- Total for service- cleaning and replacement parts- \$ 1,484.85

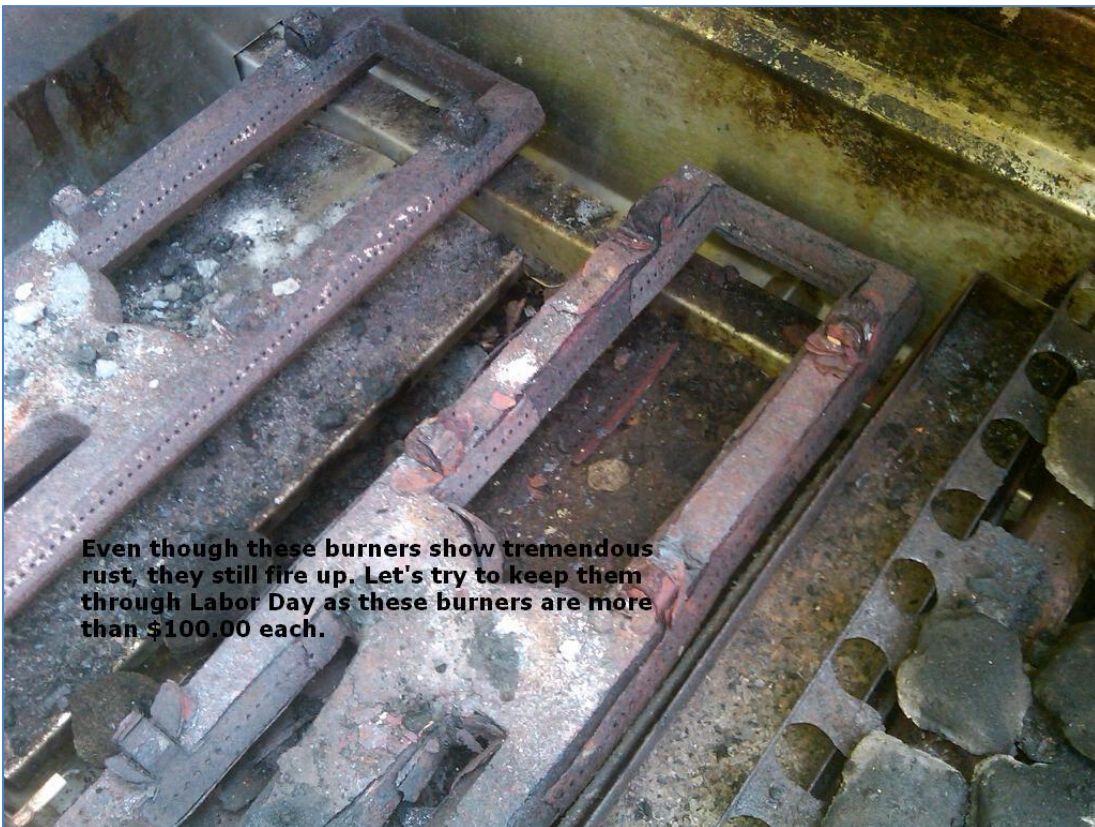
**Even though these burners show tremendous rust, they still fire up. Let's try to keep them through Labor Day as these burners are more than \$100.00 each.**

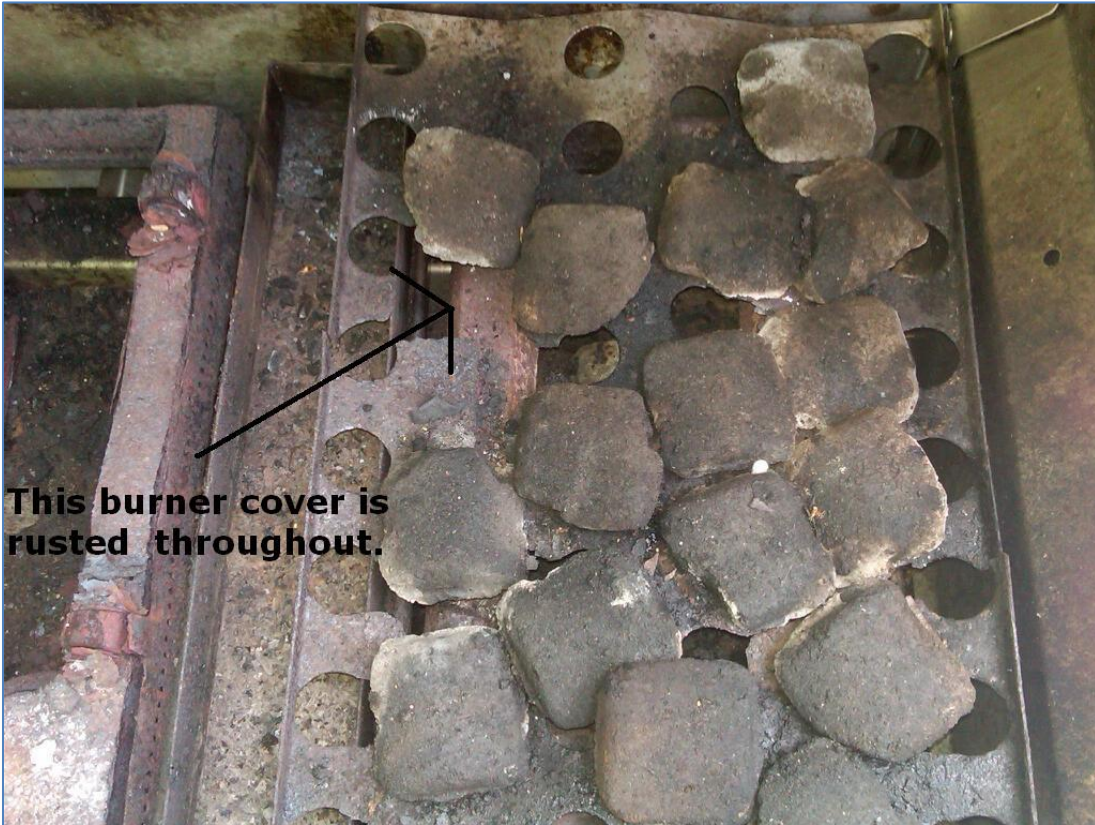
**This burner cover is rusted throughout.**

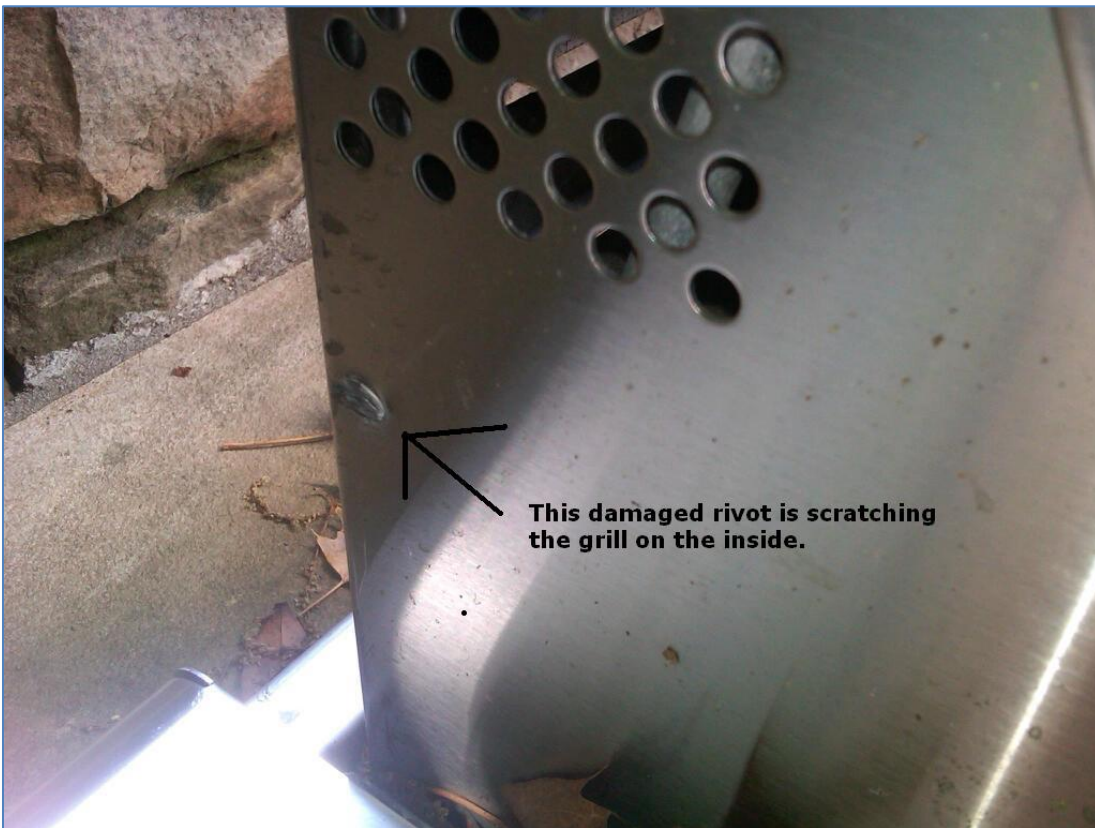
**This damaged rivot is scratching the grill on the inside.**
